LEVI WETHERBEE FARMHOUSE

**Conditions Assessment and Preservation Plan for the
LEVI WETHERBEE FARMHOUSE**

December 19, 2016

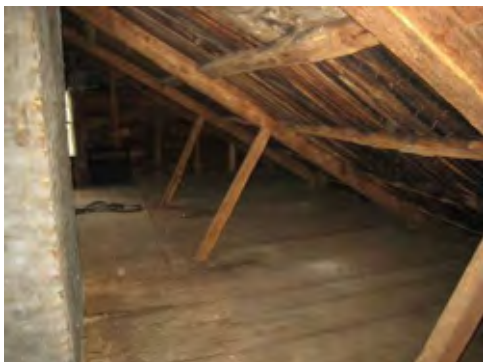
The roof framing is in fairly good condition and appears to be performing well, despite the relatively small sizes of the roof purlins.

Any eventual future re-roofing projects should avoid adding additional layers of roofing, and should involve complete removal of the existing shingles prior to adding new roofing materials. This method will eliminate any increase in dead load on the existing structure and maintain its historic performance. Additionally, the application of any insulation should be avoided at the attic or roof level without substantial framing reinforcement. Similar to avoiding an increase in the dead

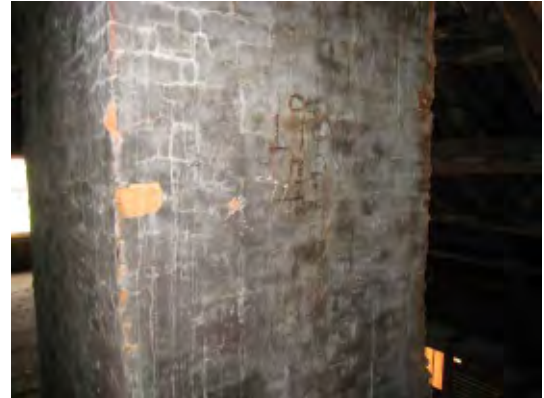
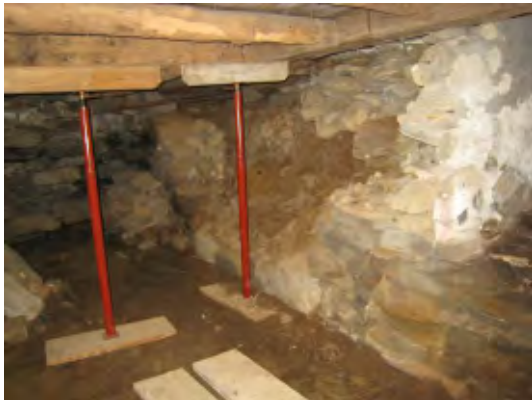
The foundation walls that support the chimney are severely compromised, particularly the west chimney wall, which has already partially collapsed. The stones from the collapsed section have been stacked at adjacent walls in an attempt to arrest further movement of these walls. While shoring of the first floor has been added at the northwest corner, little else has been done to the foundation walls to prevent further collapse. Additionally, the balance of the foundation walls is bowing inward, with fewer locations in good condition than not.

The entire foundation needs to be shored in order to preserve the upper levels. While there are several options available to mitigate or remedy the issues presented in Groton Engineering's 2014 report, these will either be trial-and-error approaches (such as water diversion) or severely impact the useable space of the basement (such as adding shotcrete along the interior face, which would also involve pouring a new slab and would rely on tying the new shotcrete into the first floor framing). The best solution is to temporarily shore the entire structure above the top of the foundations in a manner that would allow for an entirely new concrete foundation to be installed. The design of the new foundations should be cantilever retaining walls so that they are independently stable and do not rely on the first floor framing for lateral support.

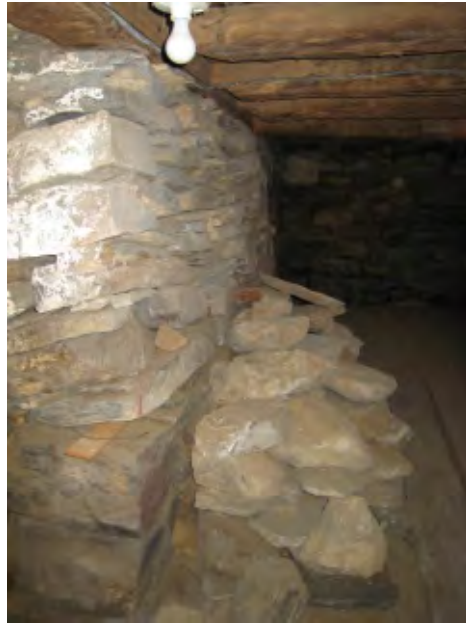
Photo 1: Failing foundation wall, east side of chimney (facing north, toward Middle Road)

Photo 1
Failing foundation wall, east side of chimney
(Facing north, toward Middle Road)

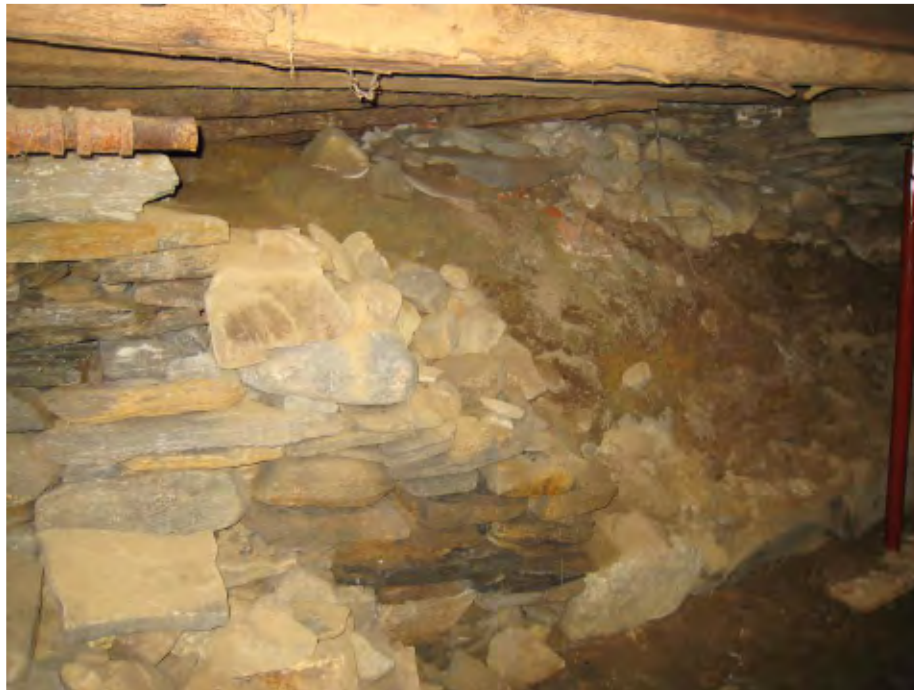
Photo 2: Failing foundation wall, west side of chimney (facing east, toward driveway/parking area)

Photo 2
Failing foundation wall, west side of chimney
(Facing east, toward driveway/parking area)

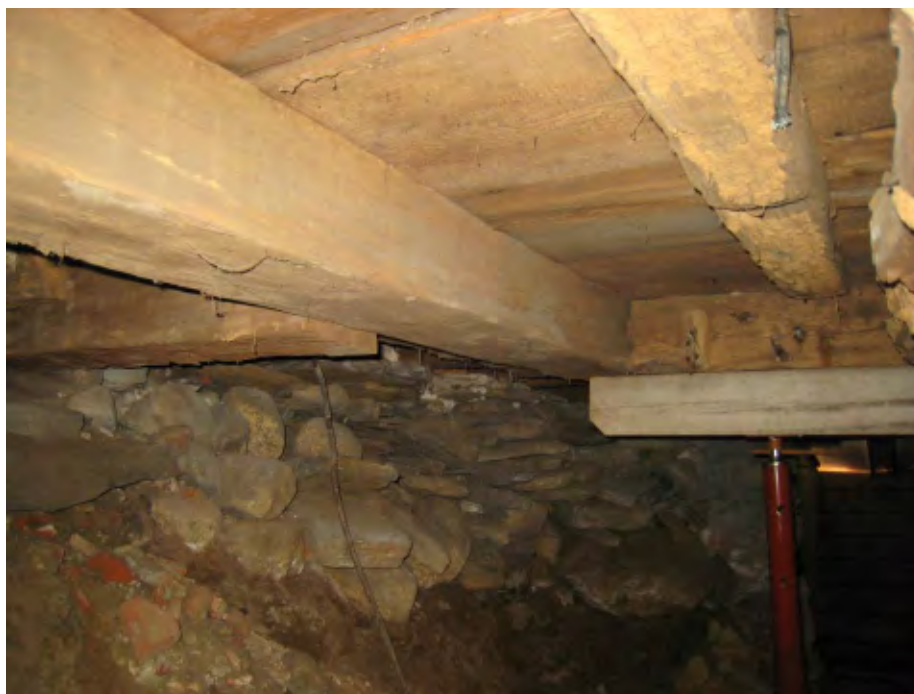
The first floor framing appears to be in relatively good condition at the southern two thirds of the footprint; however rear/north portion is rot- and insect-damaged. The damage at the east section appears to be minimal enough so that the floor is still stable, while the west section has been reinforced. The west-most joist has not been reinforced, and is not in contact with the subfloor. The damage at the center-north section is severe enough to have resulted in a collapse at the north end; while this space is generally inaccessible, it is likely that the sill is rotted at this location as well. The collapse of the west chimney wall has resulted in unsupported notched tenons of timber beam ends, which were likely previously receiving full-depth support from the collapsed walls. One of these has been restored by means of temporary shoring, while the other is not and appears to be splitting, which is common with this type of connection (see photos 3 & 4 on Page 2 of the Appendix).

Photo 3
Beam previously supported by now-collapsed chimney wall
(Facing south, toward barn)

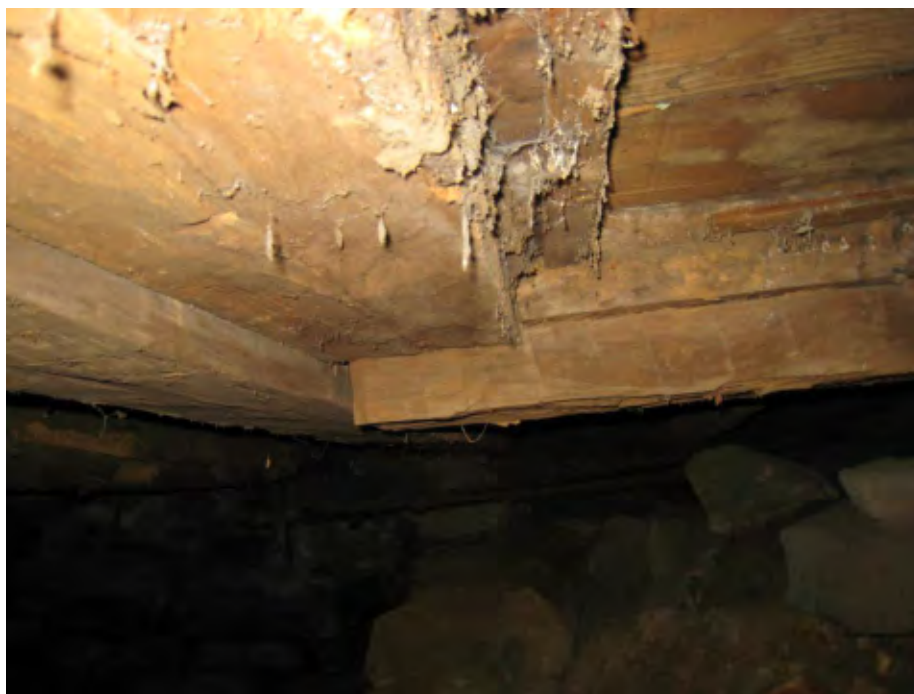
Photo 4
Beam previously supported by now-collapsed chimney wall
(Facing north, toward Middle Road, showing split at mid-depth)

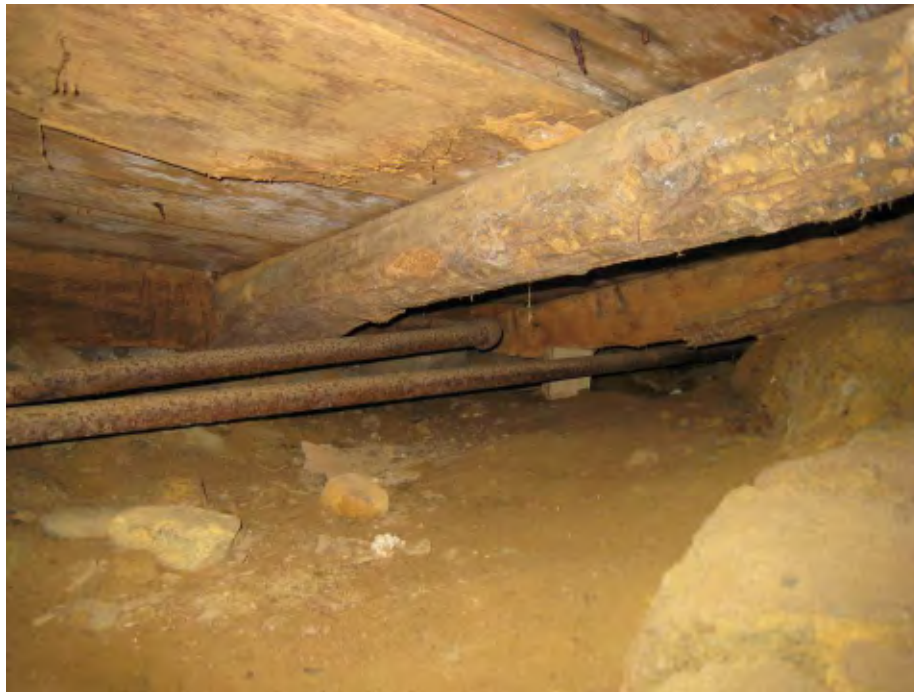
Photo 5: Collapsed first floor framing section (facing north/Middle Road, center section north of chimney as viewed from crawlspace)

Photo 5
Collapsed first floor framing section
(Facing north/Middle Road, center section north of chimney as viewed from crawlspace)

As part of the restoration and repair, the north half of the first floor framing will require a combination of reinforcement and replacement, including sill replacement. Portions of this scope will need to precede the lifting/shoring of the structure to remain.

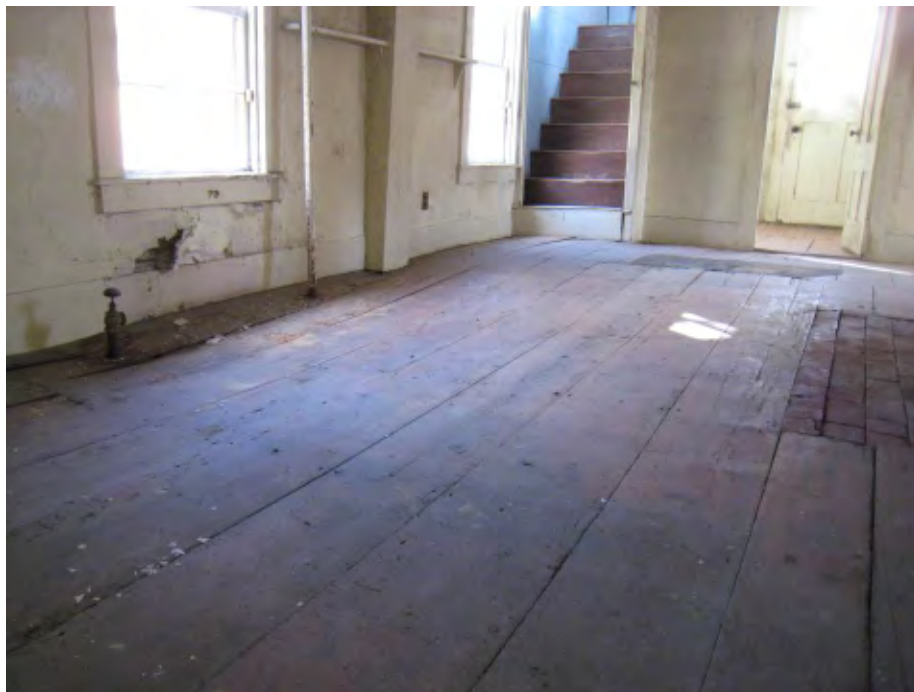
Photo 6: Collapsed first floor framing section (facing northeast/Middle Road, center section north of chimney as viewed from first floor)

Photo 6
Collapsed first floor framing section
(Facing northeast/Middle Road, center section north of chimney as viewed from first floor)

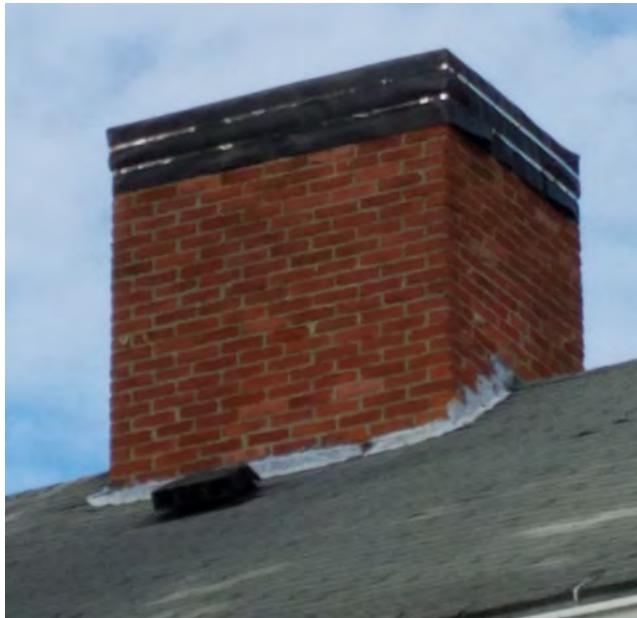
Chimney

- The exterior of the brick masonry chimney was observed through binoculars from the ground and it appears to be in moderate condition. Based on an inscription in the attic, there was work done on the chimney in 1990. Above the roof there appears to be some brick spalling on the east side. The pointing does not appear to be deteriorated.
- Step flashings are not interleaved with shingles, allowing water to get under the horizontal portion of the flashing.

- Replace spalling brick s on the east side.
- Inspect and repoint where necessary.
- When re-roofing, replace step flashings interleaving with shingles, replace the downslope apron flashing extending it 6 inches over the roofing and hemming it for stiffness.
- Replace the EPDM membrane covering over the top of the chimney with a chimney cap or other permanent measure to keep water out.

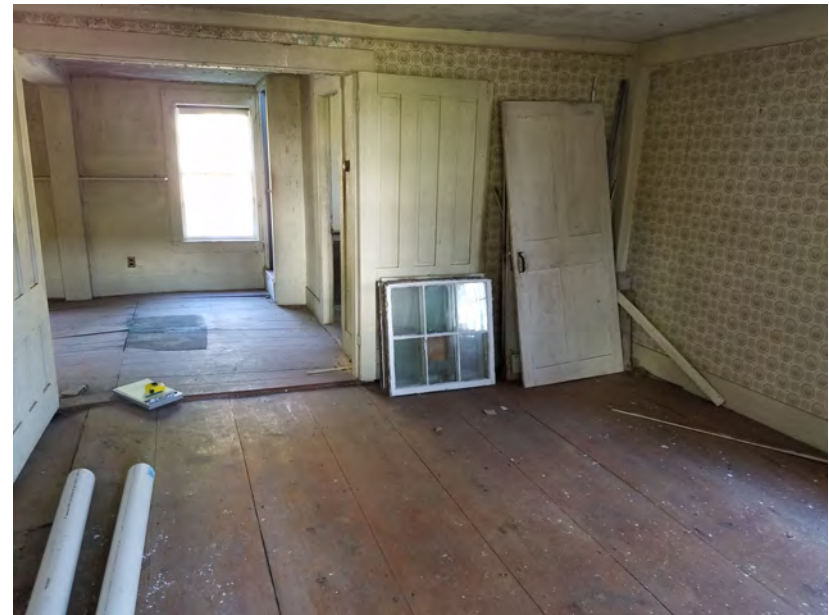
Historical sash stored in the house

- Repair historical sash that are stored in the house (approximately 12). Strip paint, remove loose glazing putty, and glass that is not well secured. Inspect corner joints and reinforce with hardwood dowels with resorcinol glue. Re-glaze where necessary. Remove modern replacement sash and reinstall refurbished historical sash.
- Scrape and paint all frame and exterior casings.
- Install window head flashings at window heads except where they exist (south side and east side of floor 1, the kitchen window, and west side of floor 2).
- Replace door casings at the south door (101)
- Remove screen door stops on the jambs at south door (101).
- Replace exterior casings, sill, and apron at east door (106) and install head flashing.

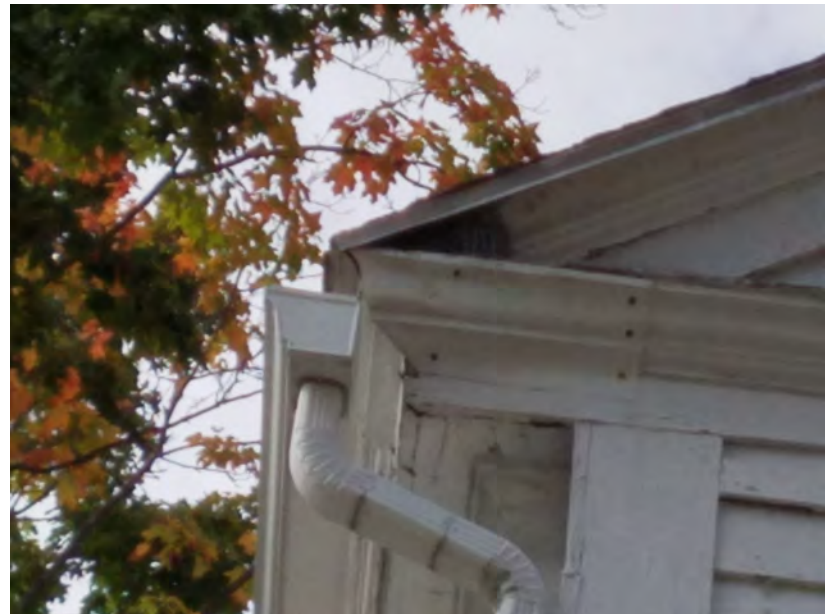
- There is a wood crown molding and fascia board along the eave and rakes. Along the eaves the molding and fascia form a boxed cornice with a soffit. The cornices return around the corners at the gable ends. There are a number of squirrel holes, especially at the southeast corner. The molding and fascia is decayed in some spots, especially behind gutters. It is not clear through binoculars whether all the cornice returns are capped with flashings.
- There are modern aluminum gutters and downspouts on the north and south eaves. Based on the presence of the crown molding, it is not likely that the house originally had gutters, but they may be a necessity until the site drainage issues (see above) are remedied.

Condition at southeast cornice return. Note sheet metal repair.

- Replace cornice moldings and fascia at squirrel holes, especially at the southeast corner, and behind gutters where decayed. Inspect cornice returns close up and install flashings at the tops if missing.
- Ideally the modern aluminum gutters and downspouts on the north and south eaves should be removed as it is not likely that the house originally had gutters, but first the site drainage issues (see above) should be remedied. A 12-16" wide gravel strip should be installed in the ground below the north and south eaves.

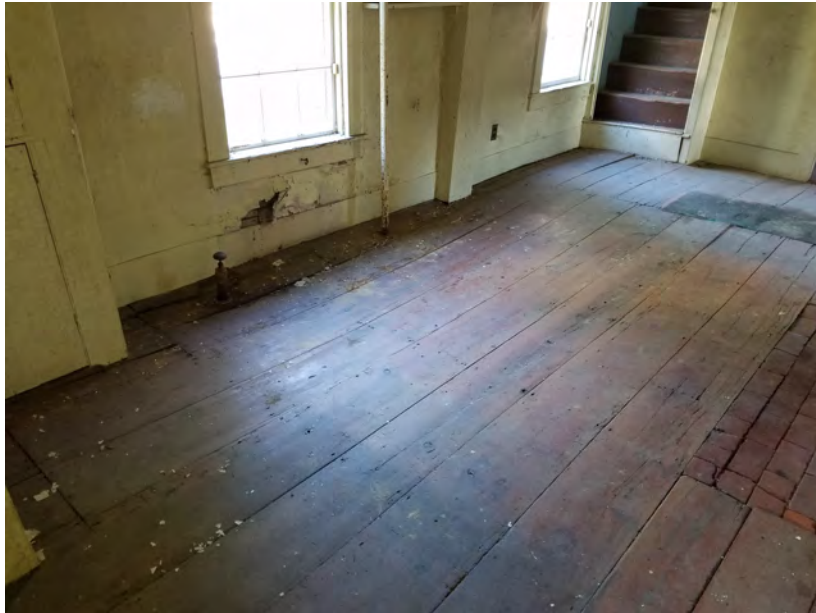
- The floor consists of 12"± wide boards.
- The wood floor is noticeably sunken between the main beams below, especially along the north wall. Several boards near the west end of the north wall are deteriorated. These conditions are related to the site drainage issues at the north side.

Sagging floor at north side of the Old Kitchen.

- Repair/replace damaged flooring at the north side. See C. Floor Framing above.

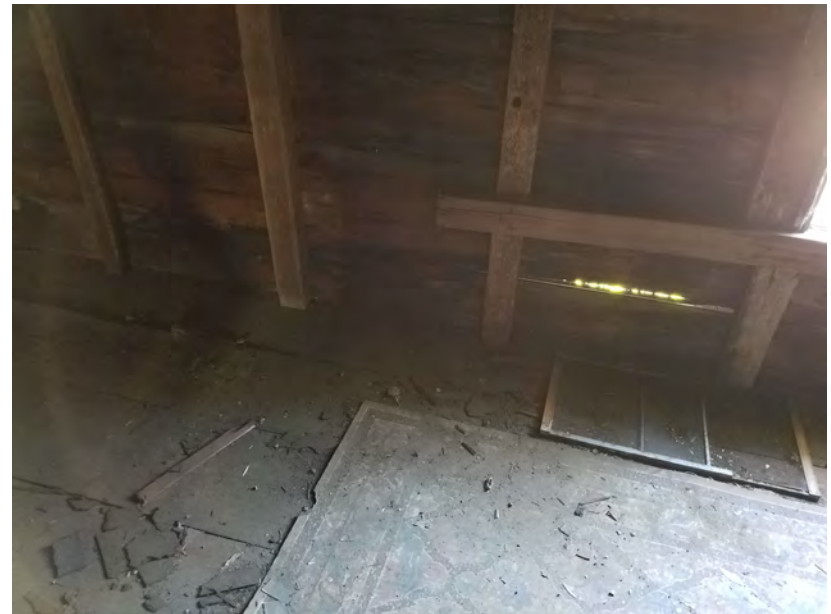
Gaps in the gable end siding and sheathing at the attic.

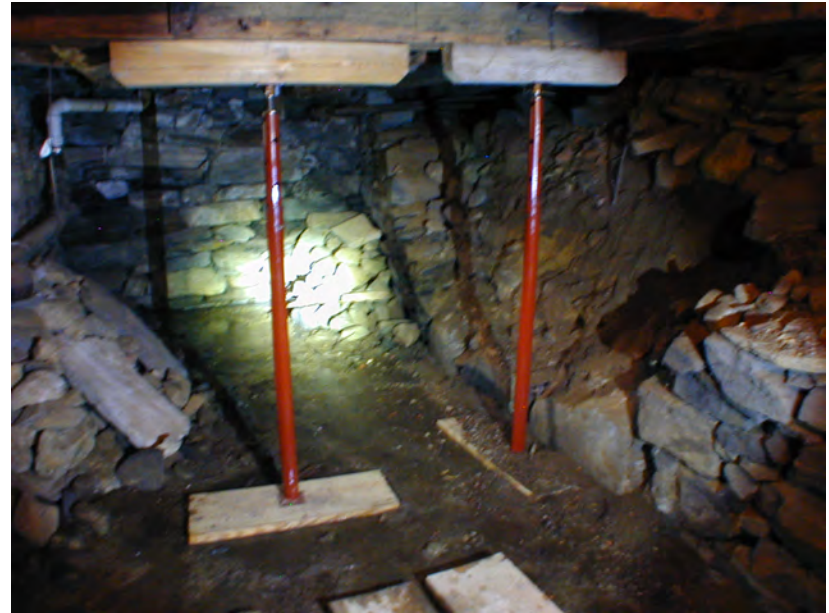
Failure of the stone foundation at the chimney.

- Temporarily shore the entire structure above the top of the foundations in a manner that would allow for an entirely new concrete retaining wall foundation to be installed. See Structural Inspection report.
- Alternate: Apply Shotcrete to the inside of the foundation wall. This method is not recommended.

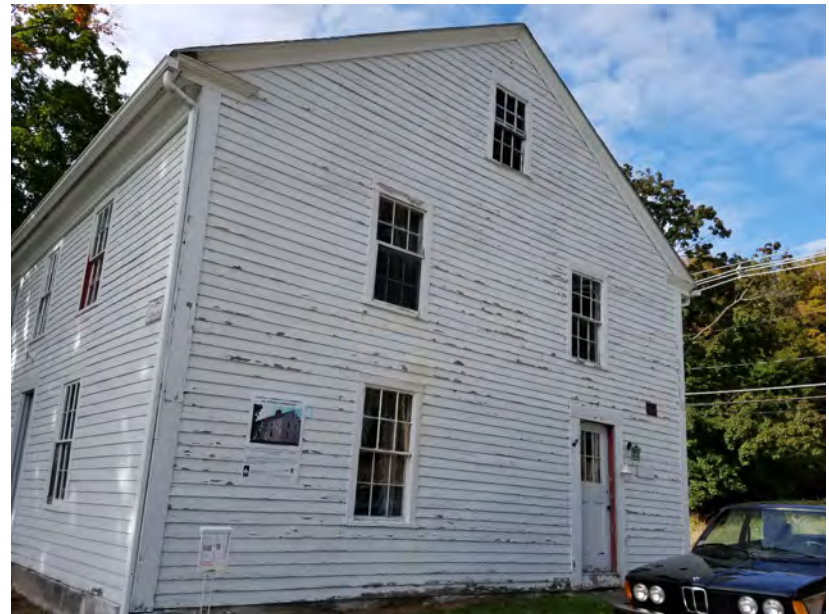
- A priority would be repainting the exterior, which is showing signs of peeling and paint deterioration which will allow siding and trim to get wet and decay.

Typical condition of paint. East side shown.

- Hand scrape off paint that is not tenaciously adhered to the substrate, hand sand ALL surfaces, feathering edges of remaining adhered paint. Assume existing paint contains lead. Take suitable precautions required by law to protect workers and prevent spread of paint dust to adjacent properties. Follow recommendations of National Park Service Preservation Brief #10 -Exterior Paint Problems on Historic Woodwork.

- Paint with one coat oil based primer and two coats acrylic alkyd house and trim paint
- Replace siding boards show splitting with pine clapboards to match (±1% on the north side, ±2-3% on the west side, ±5-7% on the south side, ±2% on the east side. Fill holes on the south side.
